Characteristics of the Rotax fuel pump P/N 893110.

All airplanes equipped with the Rotax fuel pump P/N 893110 (see Fig. 1).

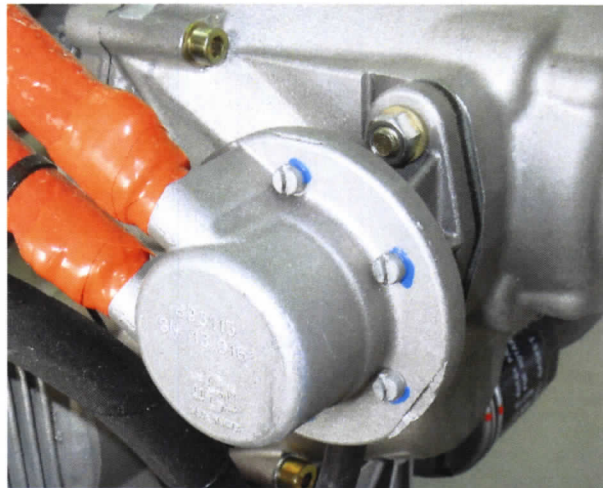
Fig. 1 - Fuel Pump P/N 893110

The fuel pump part. 893110 has different characteristics as the fuel pumps part no. 892542 and part no. 892546.

Low fuel pressure indications are possible and allowed. But the pressure must stabilize to the operating limit within 5 seconds. If not, the cause should be determined and rectified.

Due to the technical design and installation conditions (construction of the return line, etc.) pressure fluctuations, at the fuel pump part no. 893110 are possible. These pressure fluctuations within the specified operating limits are not considered to a problem.

These characteristics were also observed on the engines installed in the airplanes type WT9 Dynamic LSA.

Take into consideration.
